**Baseline Documentation**

**Warwick Neck Lighthouse and Keeper's Quarters**

1350 Warwick Neck Avenue

Warwick, R.I.

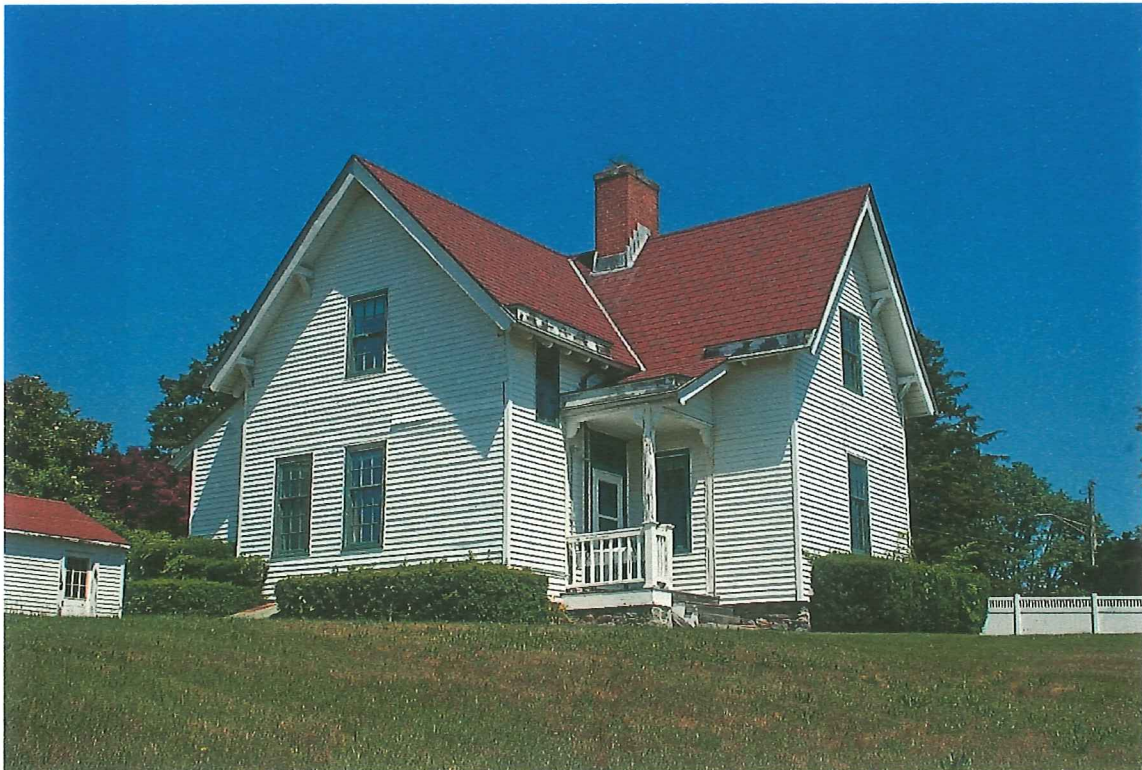
Photo 3. WARWICK NECK KEEPER'S QUARTERS, looking northwest. Note, damaged vinyl siding should be repaired to prevent damage.

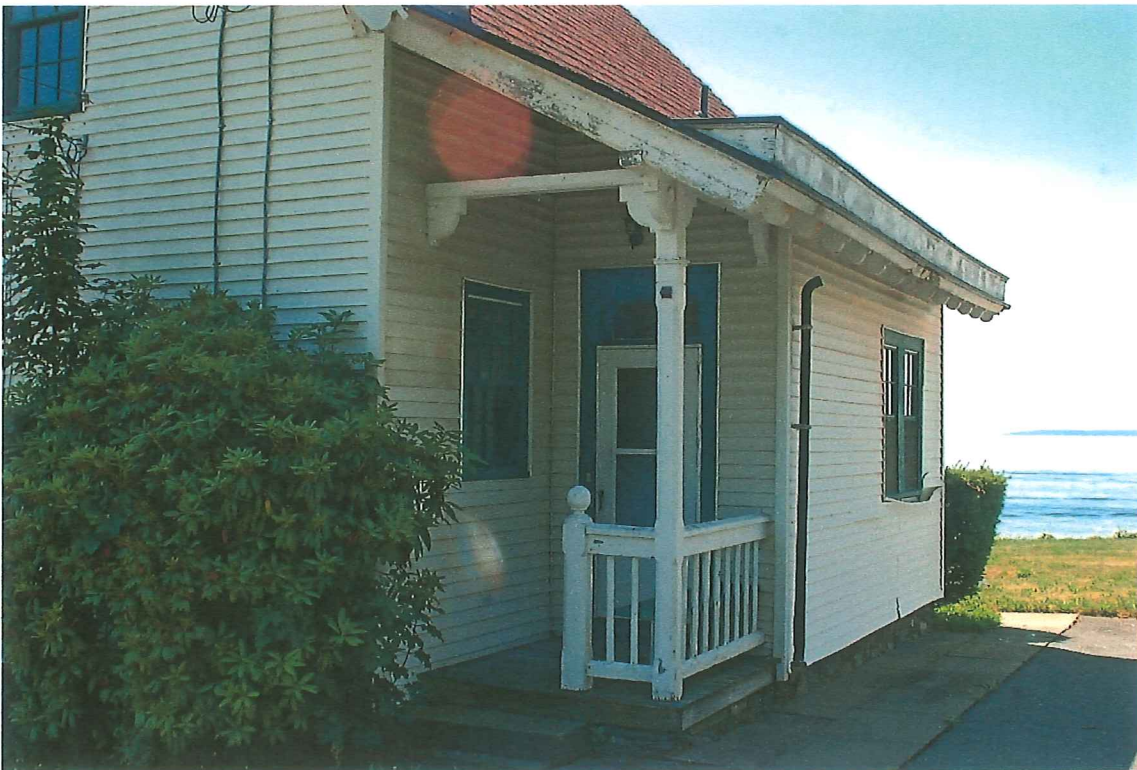
Photo 6. WARWICK NECK KEEPER'S QUARTERS, west entrance, looking southeast. Note, vinyl siding is damaged below windows, downspout is disconnected. These should be addressed as quickly as possible to prevent damage.

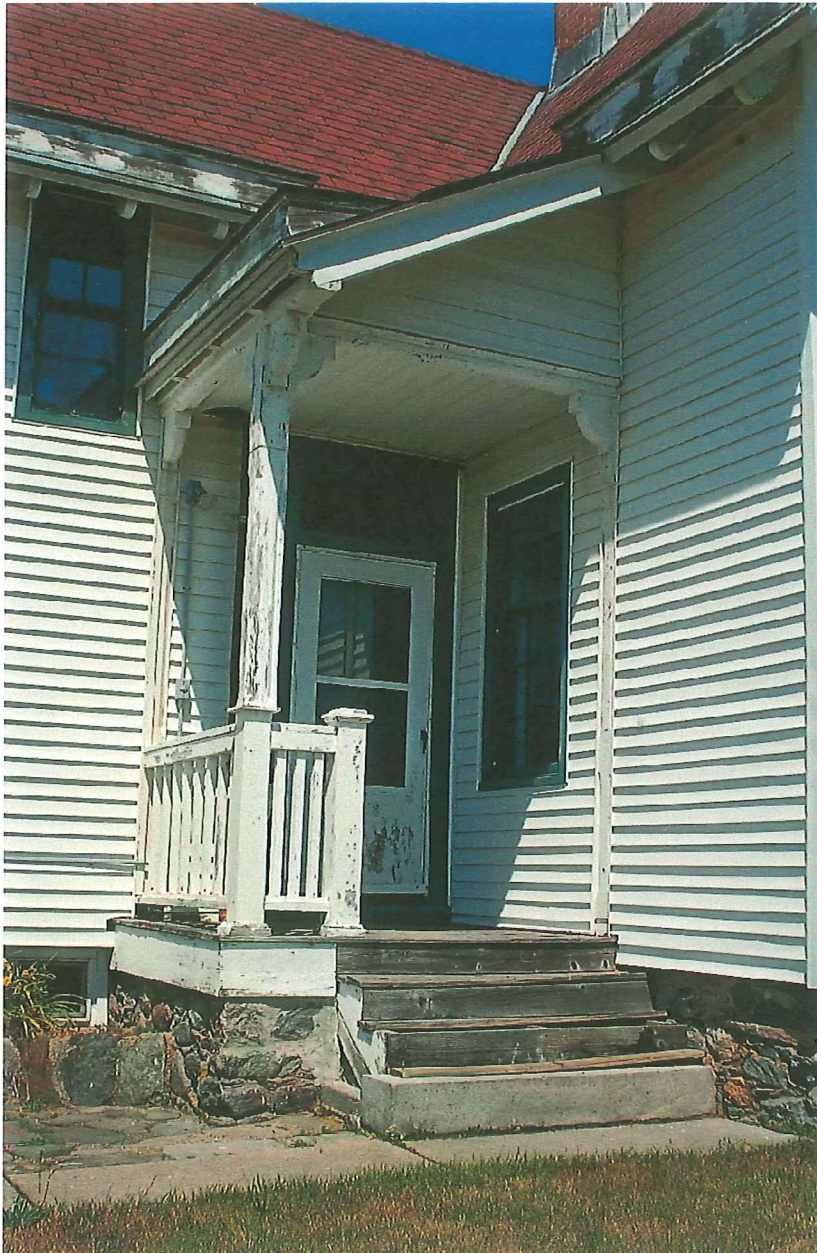
Photo 7. WARWICK NECK KEEPER'S QUARTERS, east entrance, looking west. Existing wood features need to be painted, and stairs repaired.

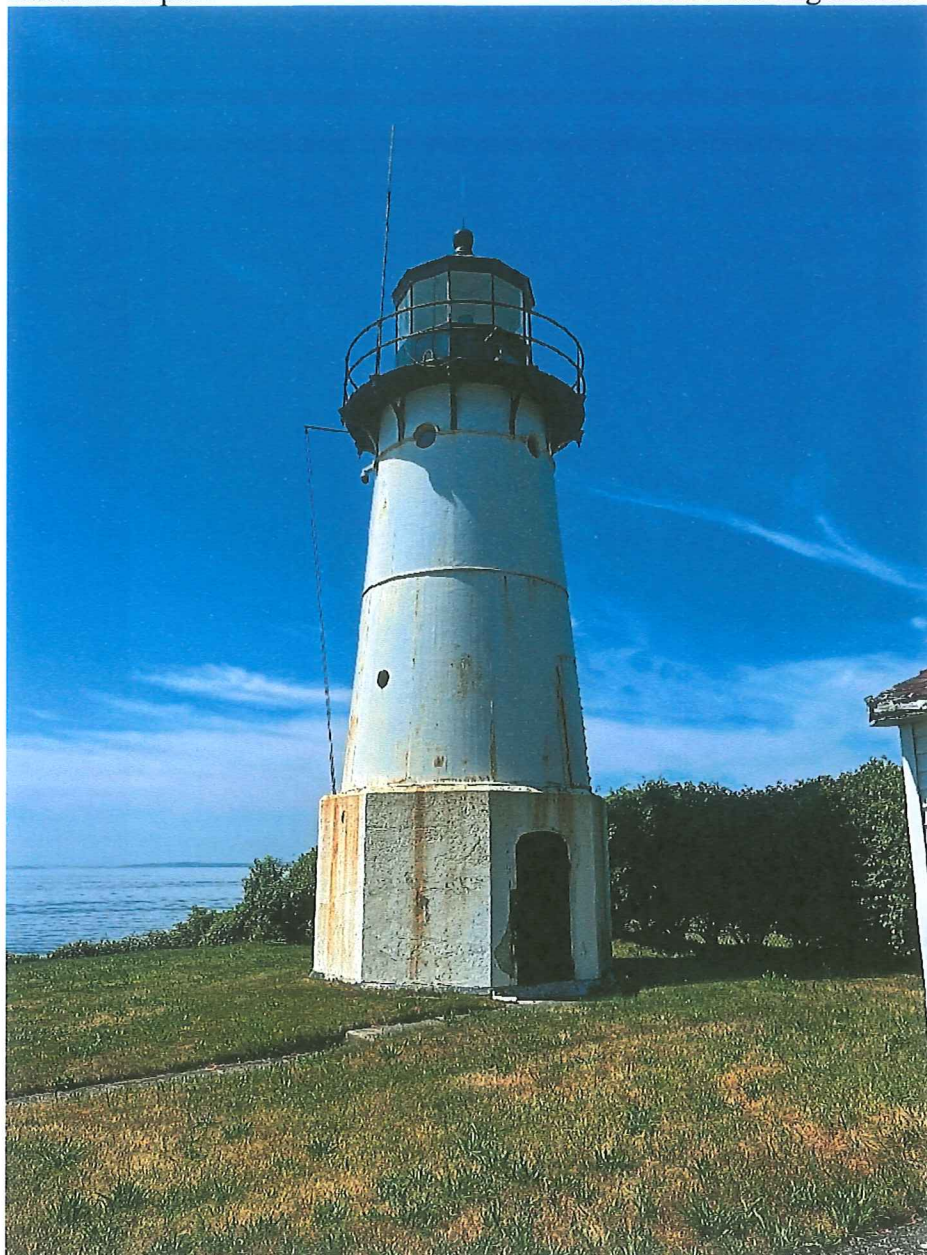
Photo 11. WARWICK NECK LIGHTHOUSE, looking southwest. Lighthouse should be recoated with appropriate paint.

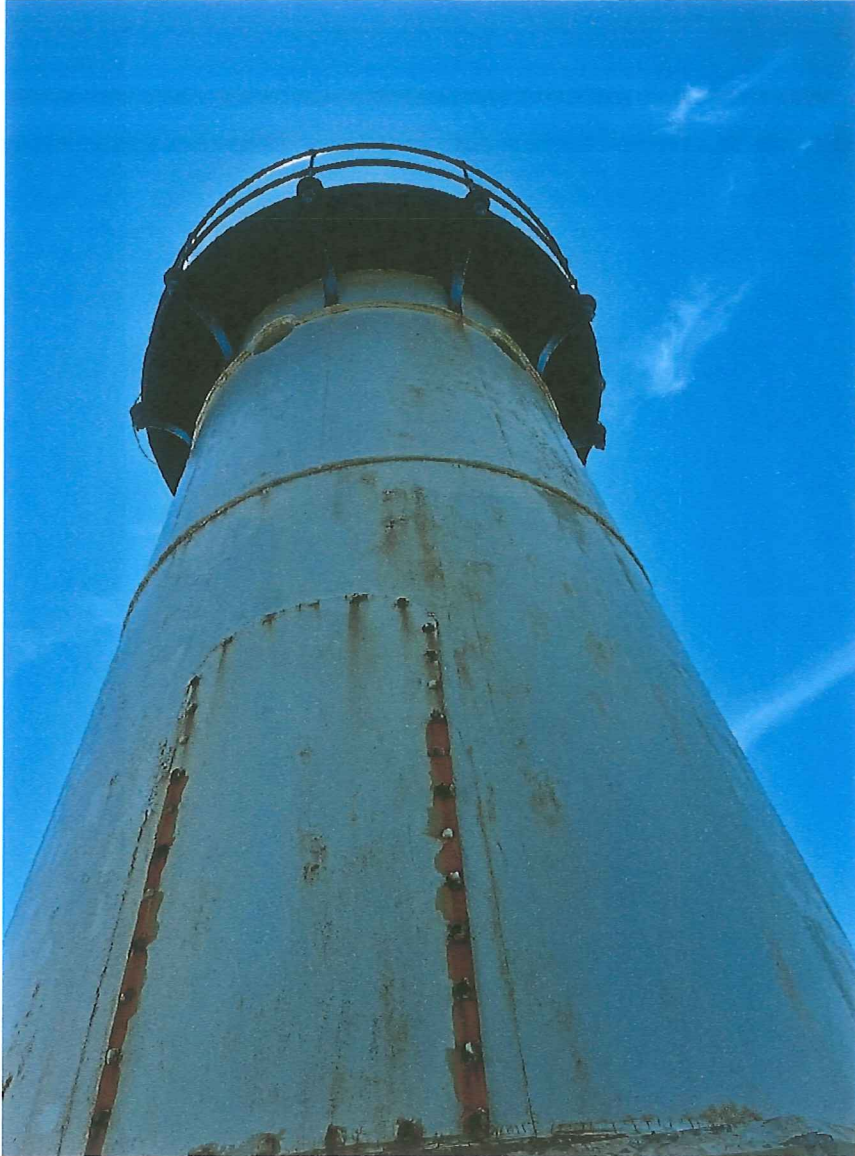
Photo 12. WARWICK NECK LIGHTHOUSE, view of former doorway. Rust should be addressed and lighthouse recoated.

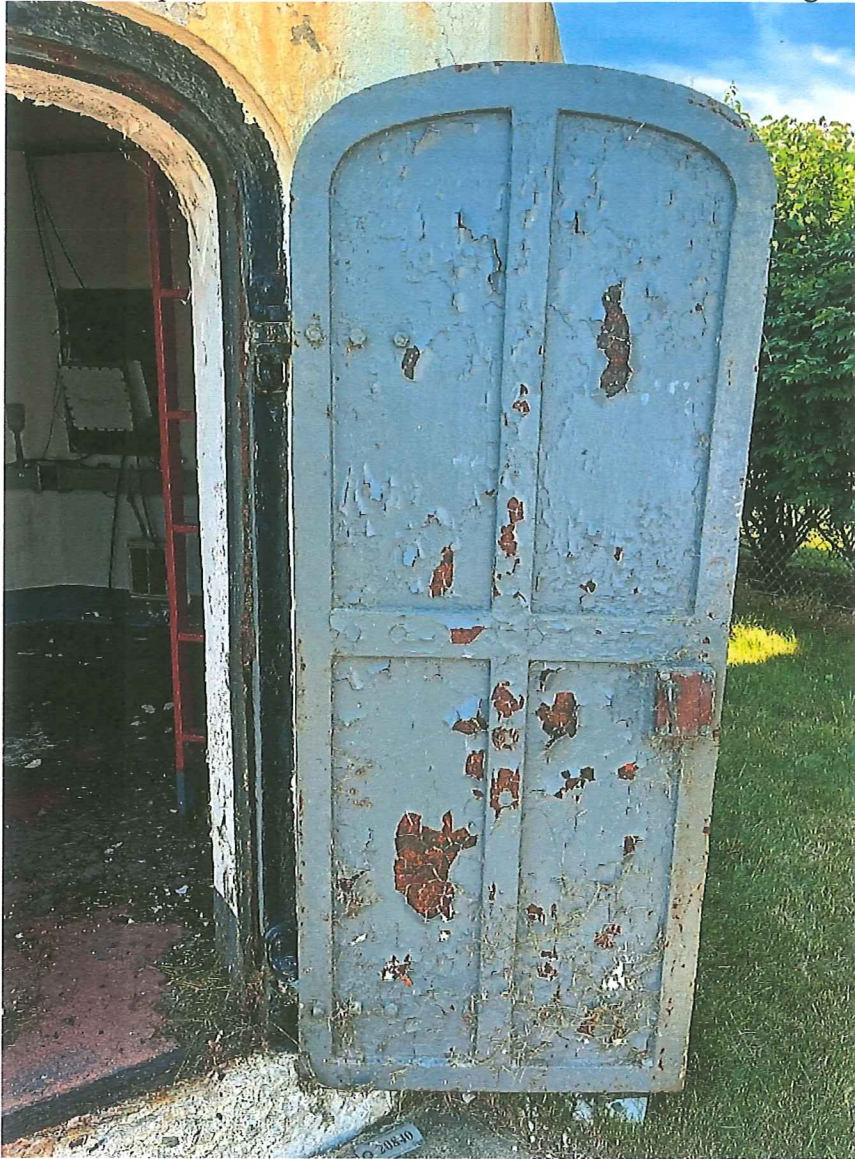
Photo 15. WARWICK NECK LIGHTHOUSE, door detail. Door should be repaired and recoated.
